Manhole Inspection Summary

Manhole # S13GG2016MH

Insp Date: **6/30/06 8:45 AM**

Location Address: **2132 WESTERN RUN DR**

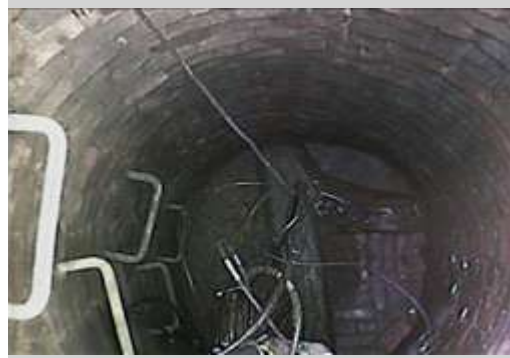
Top View

☒ **Debris** (not Condition related)

Bench debris.

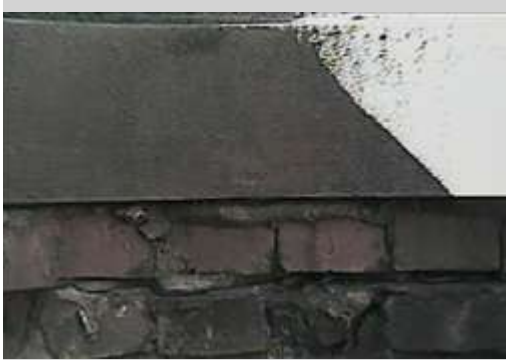
Defect

☒ **Leaks**

Condition: ☐ Sound ☐ Cracked ☐ Root Intrusion ☐ Loose Brick ☒ **Deteriorated**

Infiltration: ☐ None ☒ **Joint** ☐ Cracks ☒ **Mortar** ☐ Roots ☐ Wall

Frame leaks. Adjustment deterioration and infiltration.

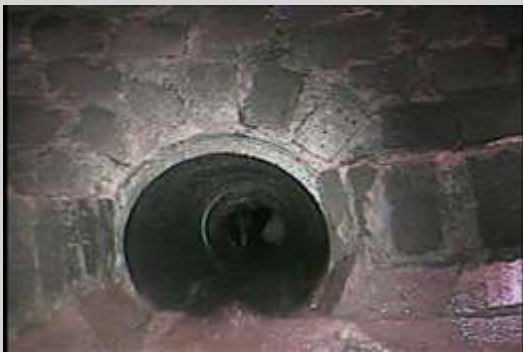
10 in. Circular Gravity Sewer Pipe Out @ 12 O'Clock

Infiltration: **Evidence** Pipe Seal Cond: **Unknown**

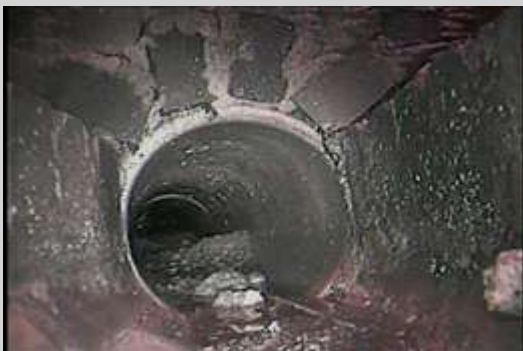
8 in. Circular Gravity Sewer Pipe In @ 3 O'Clock

Deposits: ☐ None ☐ Mud ☐ Sludge ☒ **Debris** ☐ Grease

Silt Depth: **2** (in.) Deposits Extent: **Light**
